The Road Inventory of Tualatin River National Wildlife Refuge Sherwood, OR

Prepared By:
Federal Highway Administration
Central Federal Lands Highway Division
February 2013

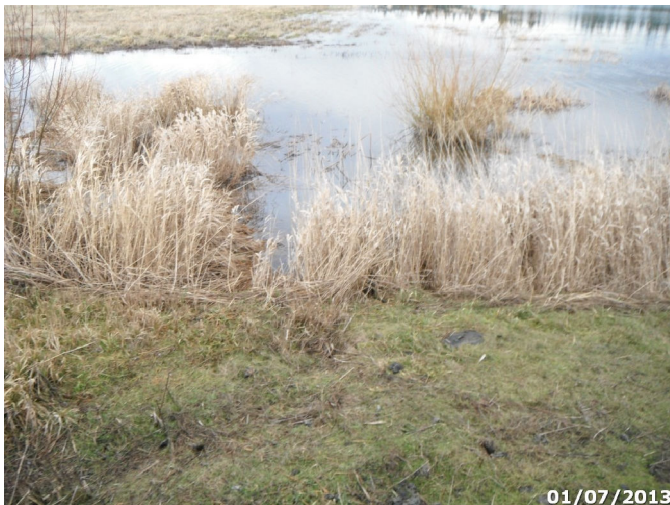
Photo: TUAL_C4_0025 Route: 400-003-2.24
Metal WCS Flashboard Riser 40ft long 24in dia. 2ft deep

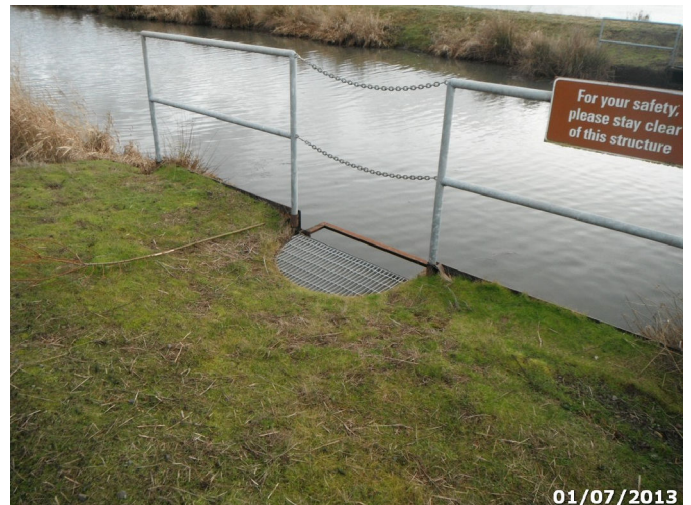
Photo: TUAL_C4_0026 Route: 400-003-2.24
Metal WCS Flashboard Riser 40ft long 24in dia. 2ft deep
8-007

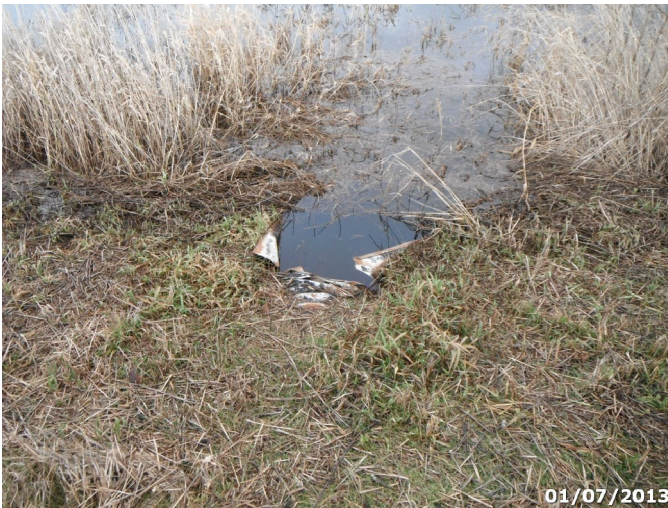
Photo: TUAL_C4_0027 Route: 400-003-2.53
Metal WCS Flashboard Riser 40ft long 24in dia. 3ft deep

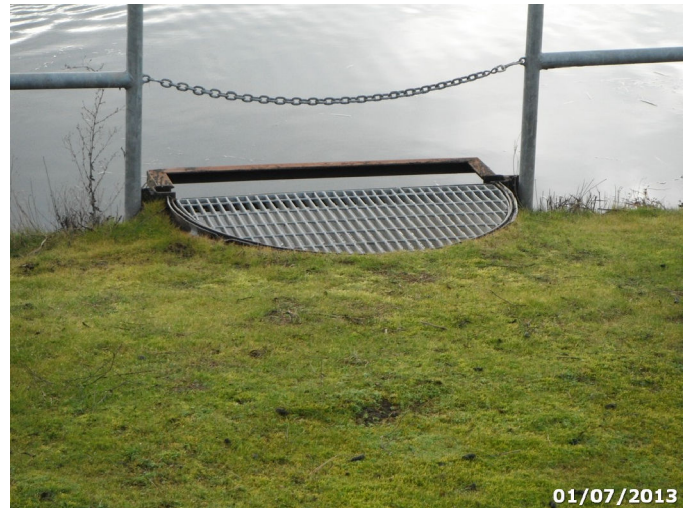
Photo: TUAL_C4_0028 Route: 400-003-2.53
Metal WCS Flashboard Riser 40ft long 24in dia. 3ft deep

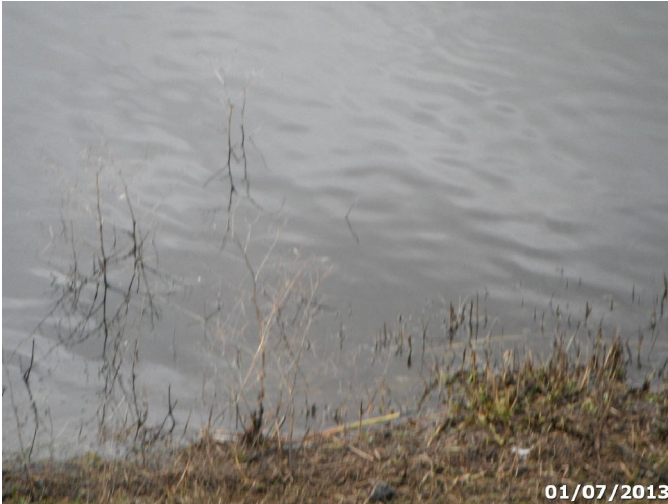
Photo: TUAL_C4_0029 Route: 400-003-2.55
Metal WCS Flashboard Riser 40ft long 36in dia. 3ft deep

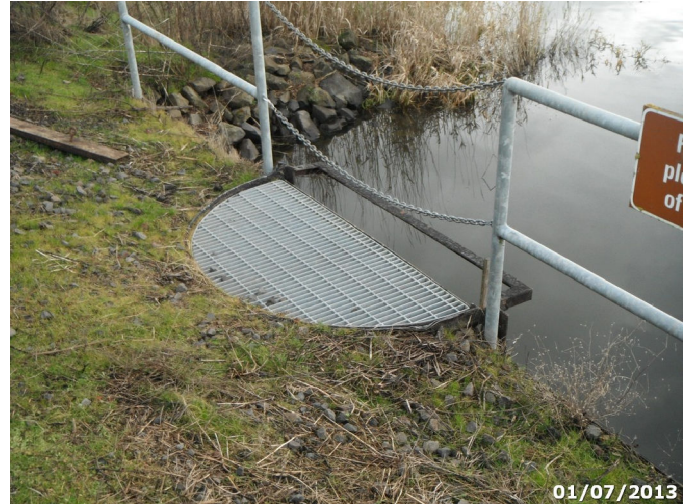
Photo: TUAL_C4_0030 Route: 400-003-2.55
Metal WCS Flashboard Riser 40ft long 36in dia. 3ft deep

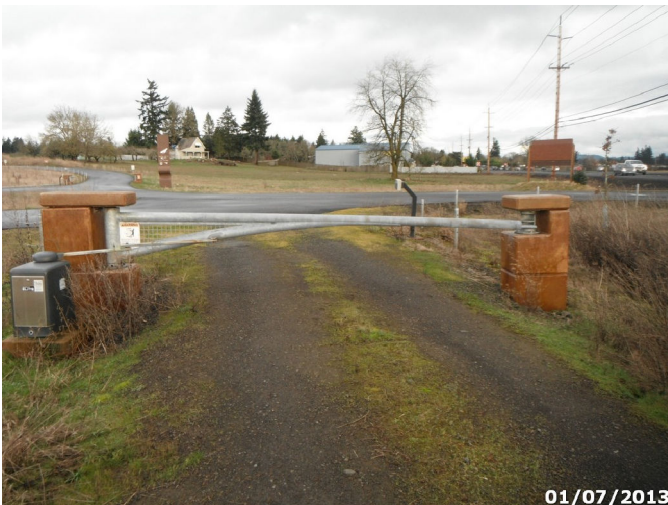
Photo: TUAL_C4_0031 Route: 400-003-2.74
Metal Open Rail Gate Electric

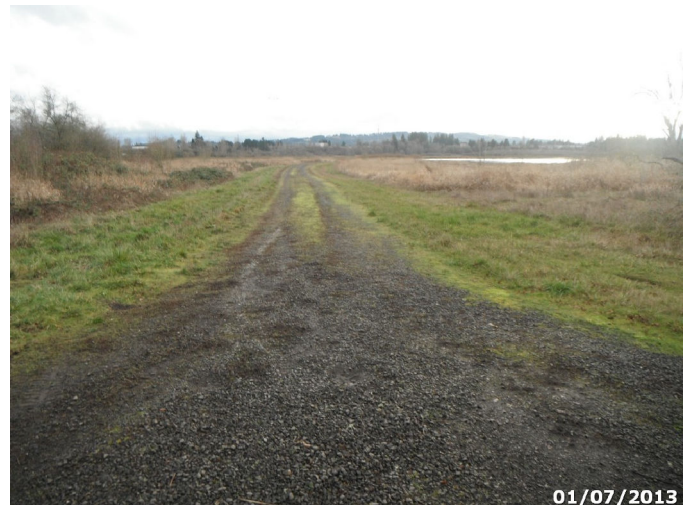
Photo: TUAL_C4_0032 Route: 400-004-0.71
Begin Section

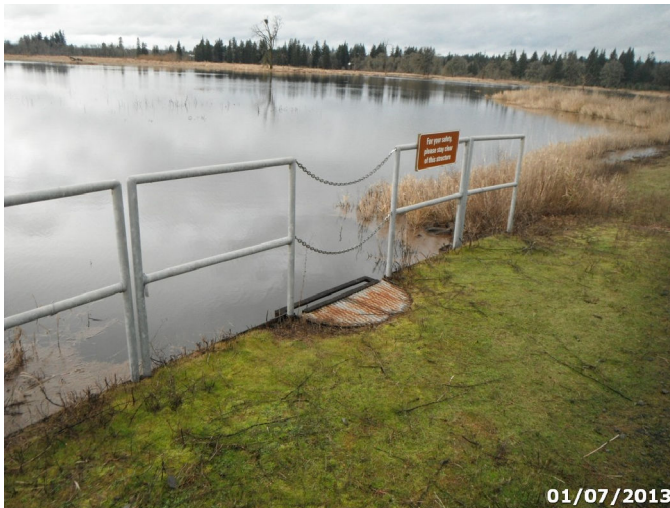
Photo: TUAL_C4_0033 Route: 400-004-1.04
Metal WCS Flashboard Riser 40ft long 24in dia. 3ft deep

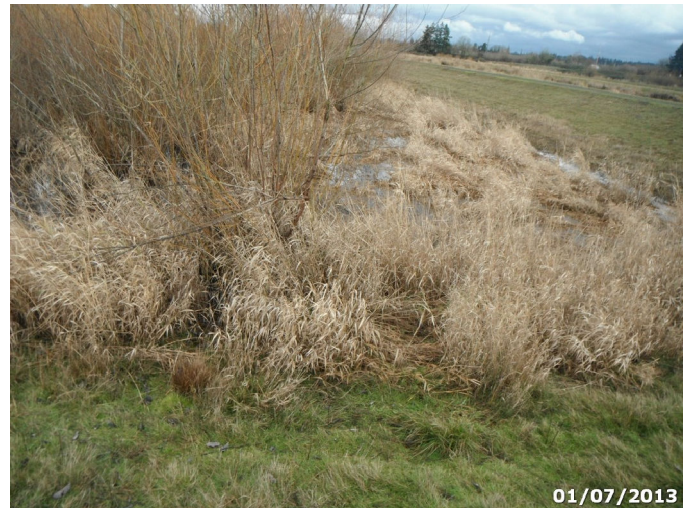
Photo: TUAL_C4_0034 Route: 400-004-1.04
Metal WCS Flashboard Riser 40ft long 24in dia. 3ft deep

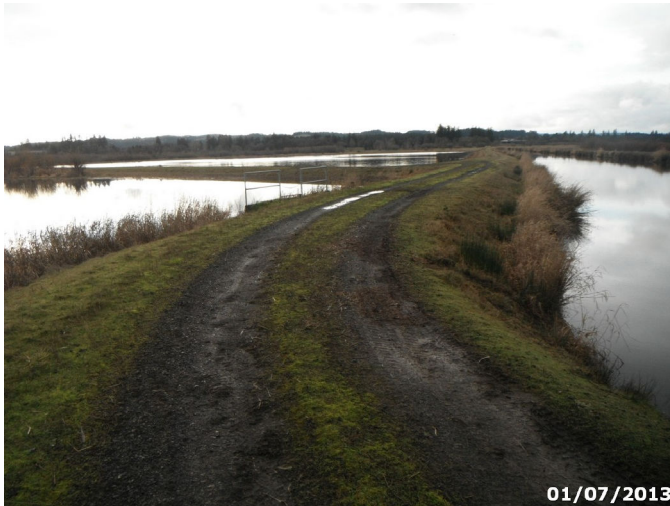
Photo: TUAL_C4_0038 Route: 400-005-2.53
Begin Section

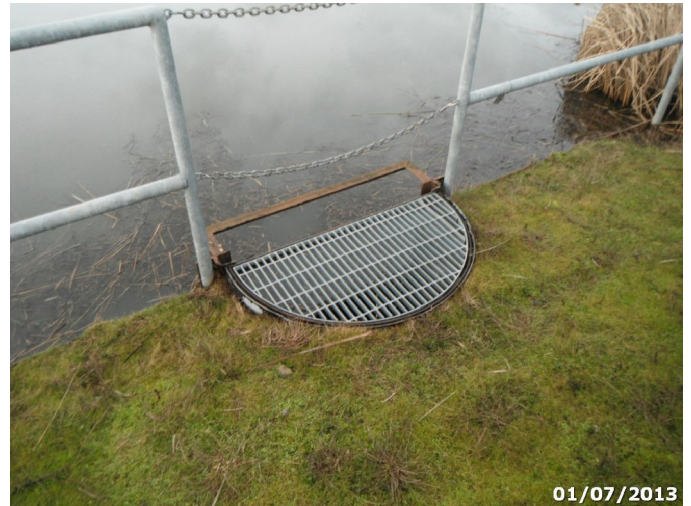
Photo: TUAL_C4_0039 Route: 400-005-2.54
Metal WCS Flashboard Riser 30ft long 24in dia. 3ft deep

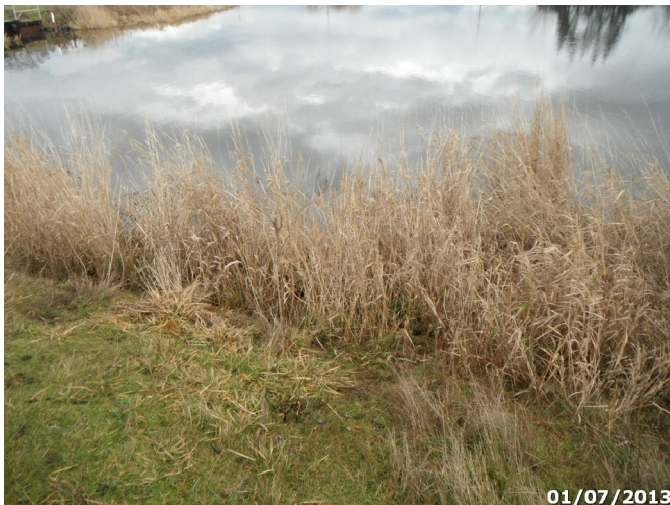
Photo: TUAL_C4_0040 Route: 400-005-2.54
Metal WCS Flashboard Riser 30ft long 24in dia. 3ft deep

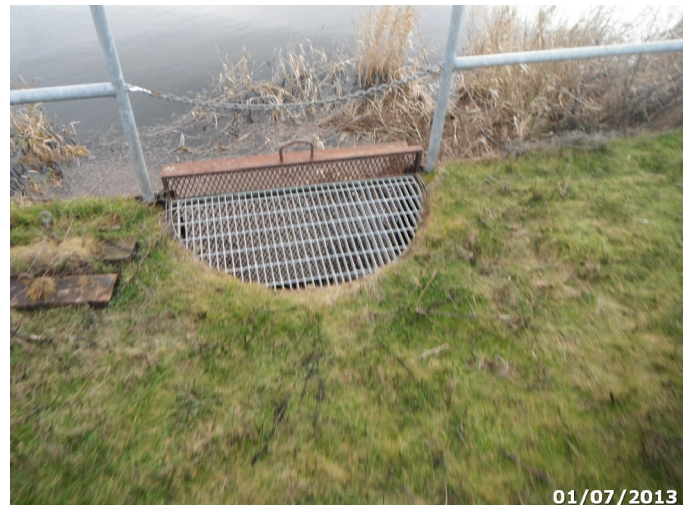
Photo: TUAL_C4_0041 Route: 400-005-2.55
Metal WCS Flashboard Riser 30ft long 36in dia. 2ft deep
8-009

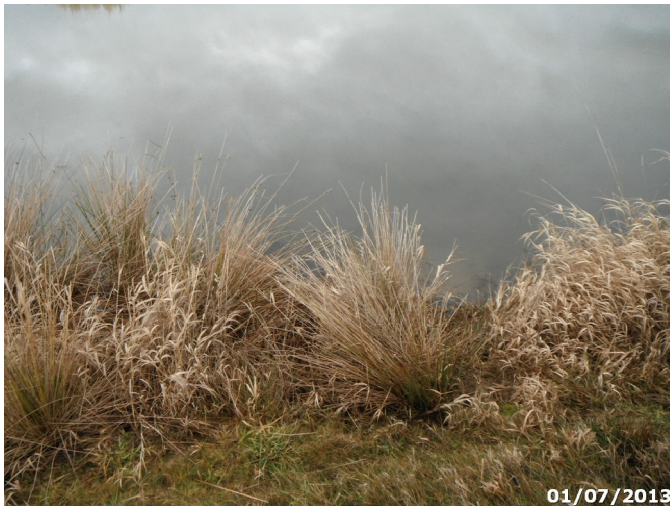
Photo: TUAL_C4_0042 Route: 400-005-2.55
Metal WCS Flashboard Riser 30ft long 36in dia. 2ft deep

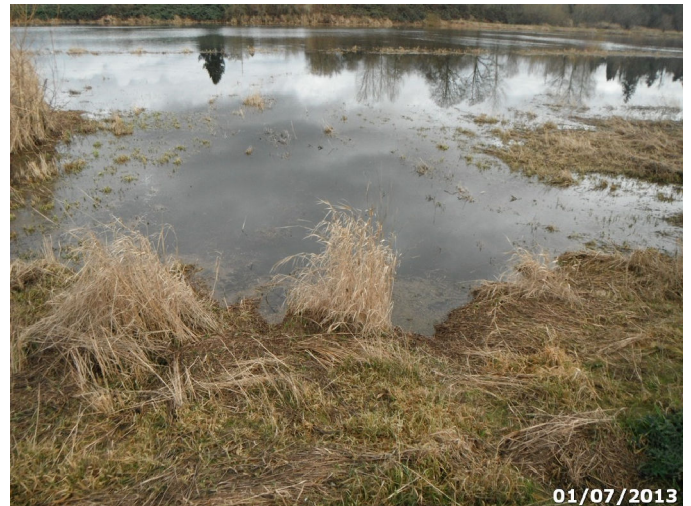
Photo: TUAL_C4_0043 Route: 400-005-2.67
Metal WCS Flashboard Riser 30ft long 36in dia. 2ft deep

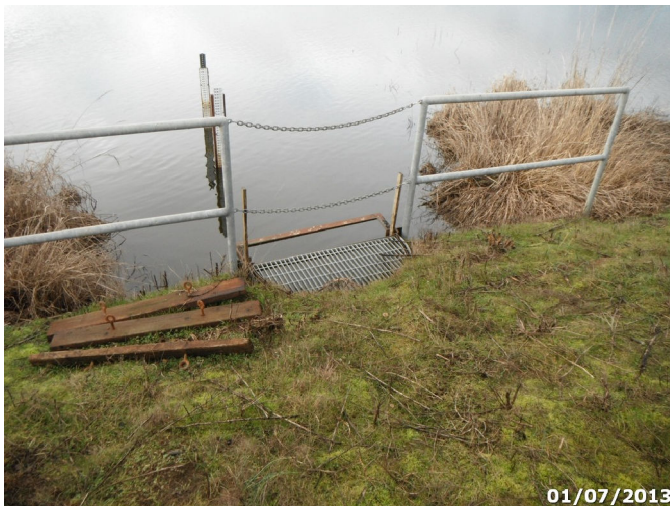
Photo: TUAL_C4_0044 Route: 400-005-2.67
Metal WCS Flashboard Riser 30ft long 36in dia. 2ft deep

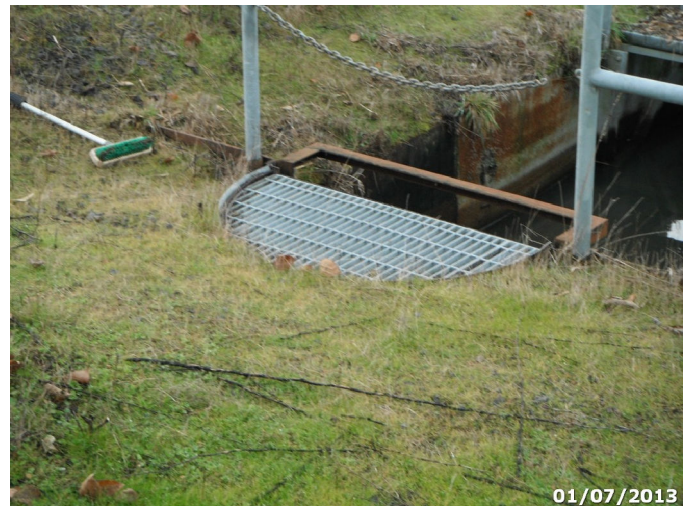
Photo: TUAL_C4_0045 Route: 400-005-3.46
Metal WCS Flashboard Riser 40ft long 24in dia. 2ft deep

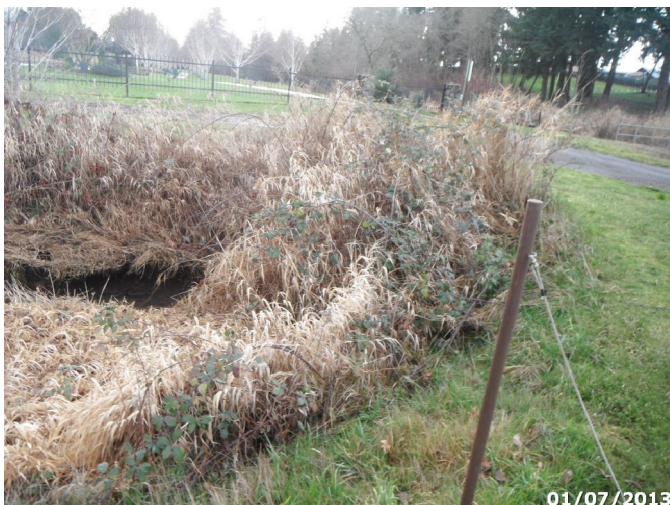
Photo: TUAL_C4_0048 Route: 400-005-3.46
Metal WCS Flashboard Riser 40ft long 24in dia. 2ft deep

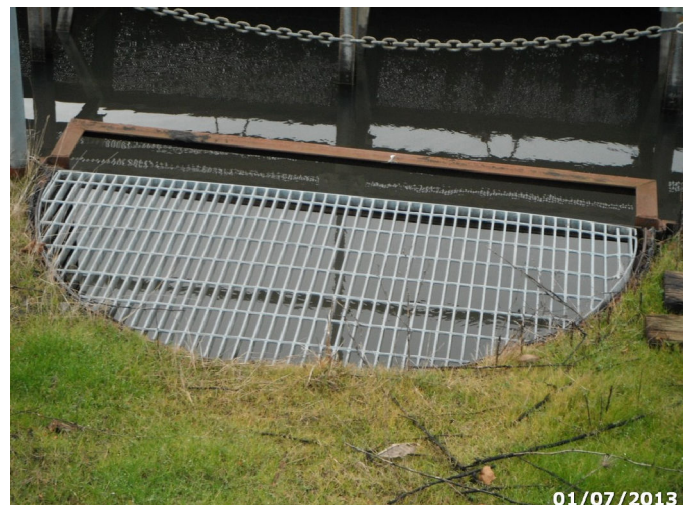
Photo: TUAL_C4_0046 Route: 400-005-3.46
Metal WCS Flashboard Riser
40ft long 36in dia. 2ft deep

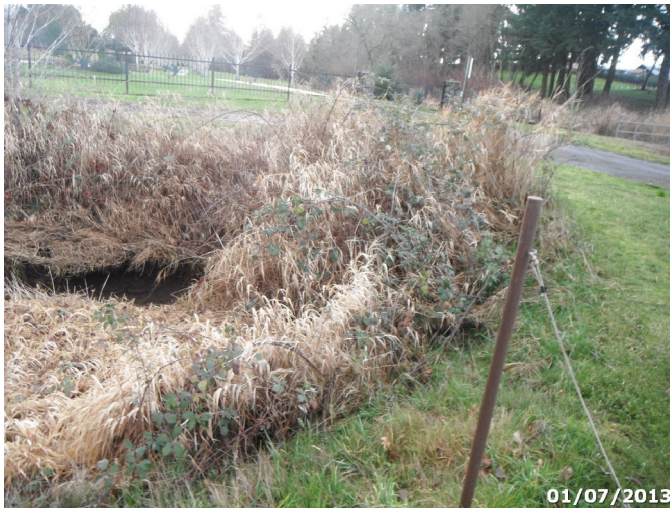
Photo: TUAL_C4_0048 Route: 400-005-3.46
Metal WCS Flashboard Riser 40ft long 36in dia. 2ft deep

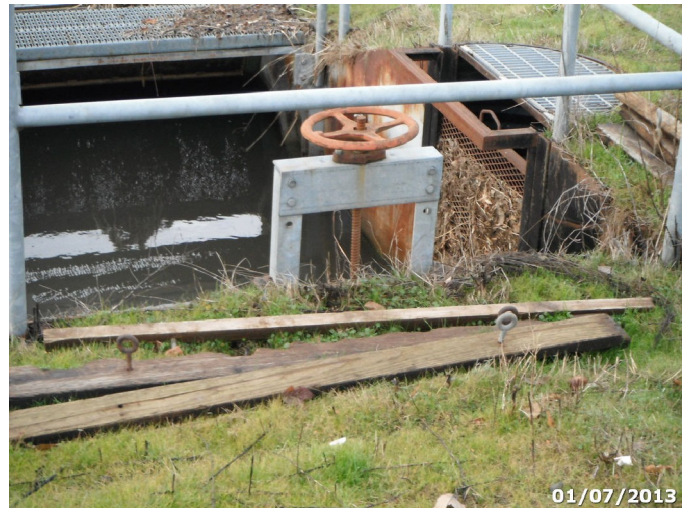
Photo: TUAL_C4_0047 Route: 400-005-3.46
Metal WCS Screw Gate 40ft long 12in dia. 2ft deep

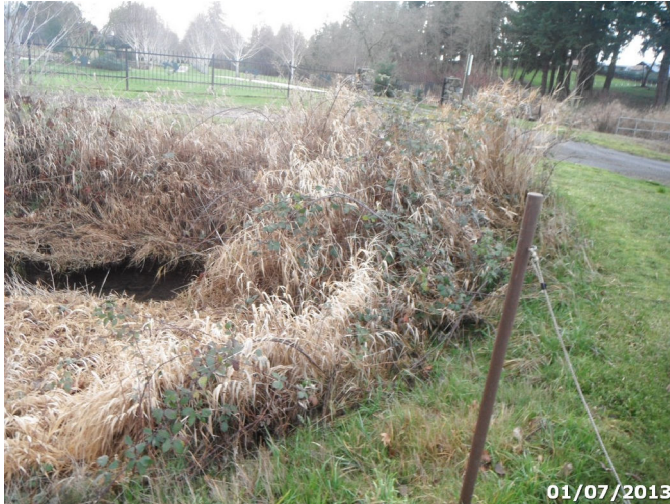
Photo: TUAL_C4_0048 Route: 400-005-3.46
Metal WCS Screw Gate 40ft long 12in dia. 2ft deep

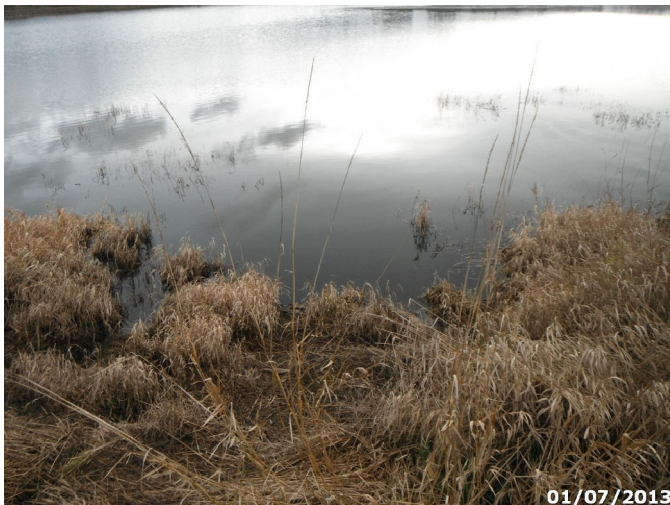
Photo: TUAL_C4_0036 Route: 400-006-2.83
Metal WCS Flashboard Riser 30ft long 24in dia. 3ft deep

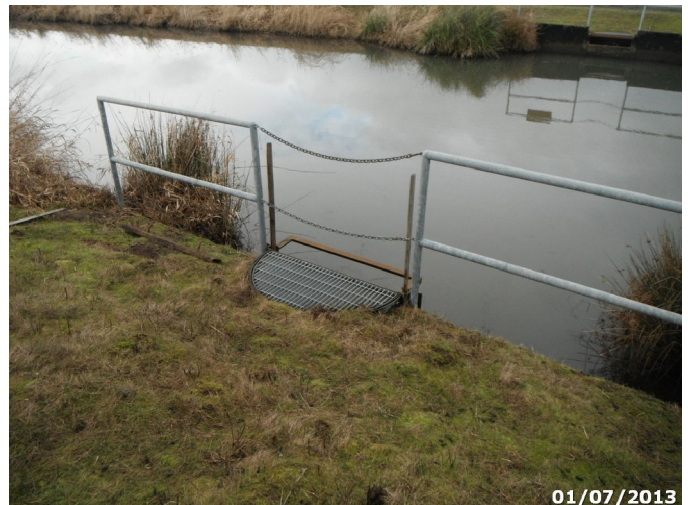
Photo: TUAL_C4_0037 Route: 400-006-2.83
Metal WCS Flashboard Riser 30ft long 24in dia. 3ft deep
8-011

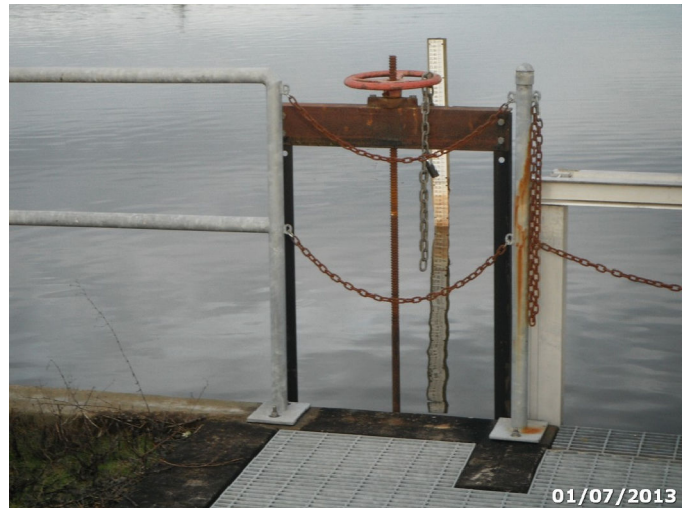
Photo: TUAL_C4_0061 Route: 401-001-0.59
Metal WCS Screw Gate 100ft long 24in dia. 3ft deep

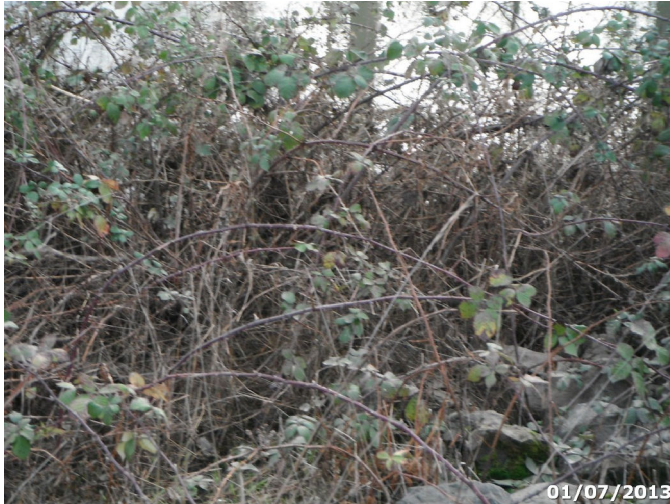
Photo: TUAL_C4_0063 Route: 401-001-0.59
Metal WCS Screw Gate 100ft long 24in dia. 3ft deep

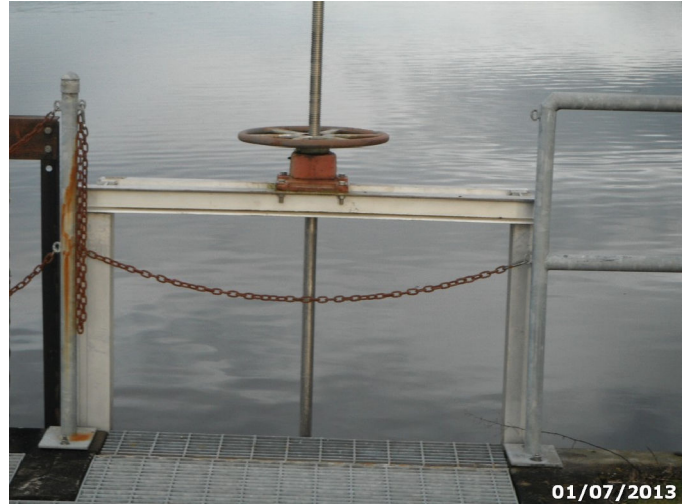
Photo: TUAL_C4_0062 Route: 401-001-0.59
Metal WCS Screw Gate 100ft long 36in dia. 3ft deep

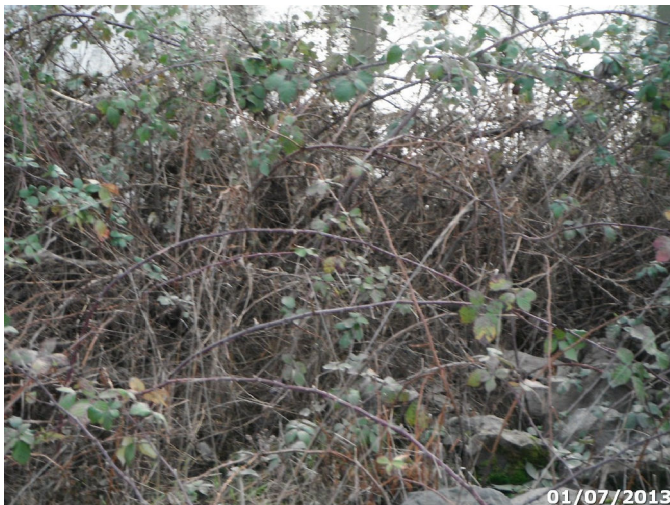
Photo: TUAL_C4_0063 Route: 401-001-0.59
Metal WCS Screw Gate 100ft long 36in dia. 3ft deep

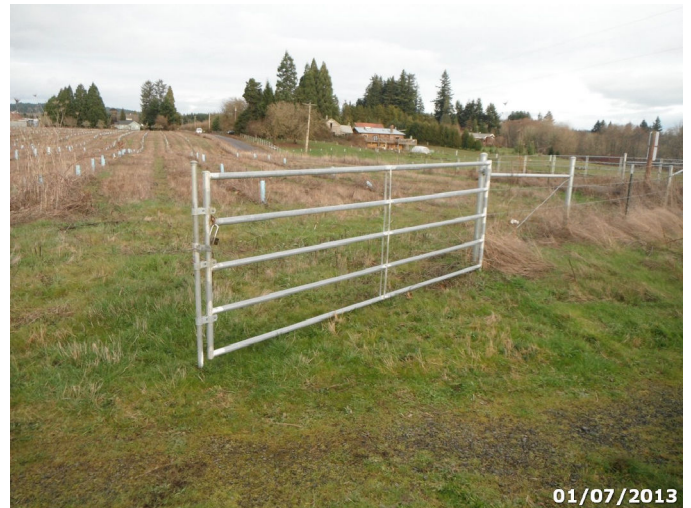
Photo: TUAL_C4_0065 Route: 402-001-0.01
Metal Open Rail Gate

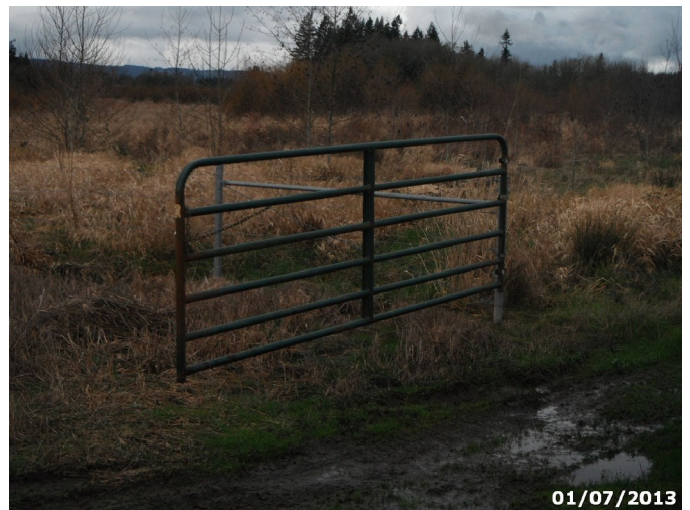
Photo: TUAL_C4_0067 Route: 403-001-0.0
Metal Open Rail Gate

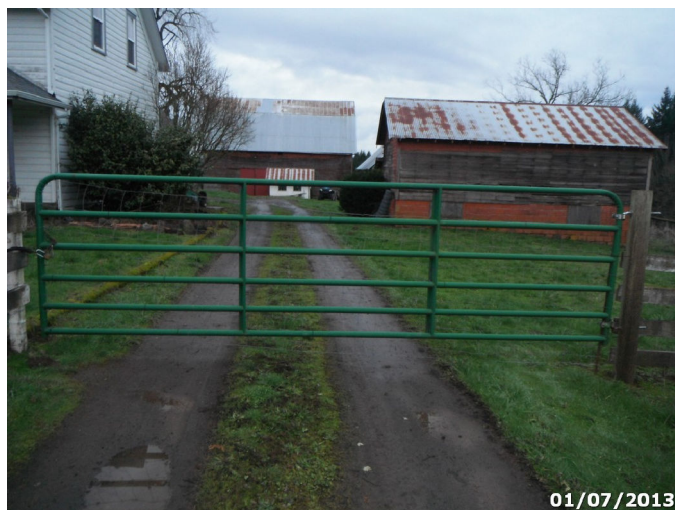
Photo: TUAL_C4_0070 Route: 405-001-0.0
Metal Open Rail Gate

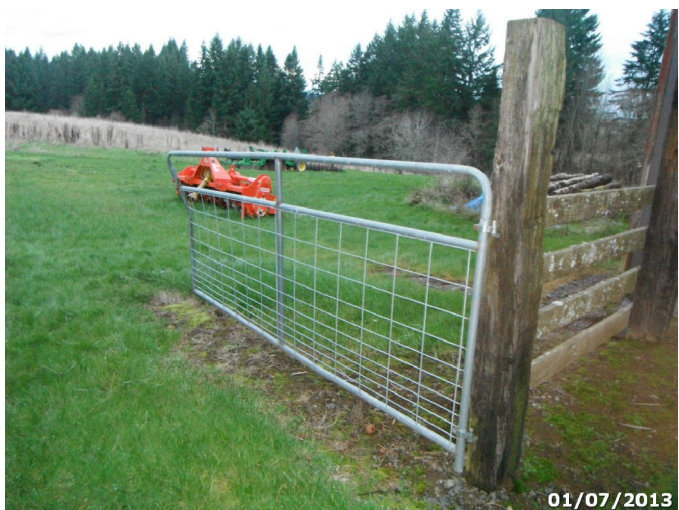
Photo: TUAL_C4_0071 Route: 405-001-0.06
Metal Open Rail Gate

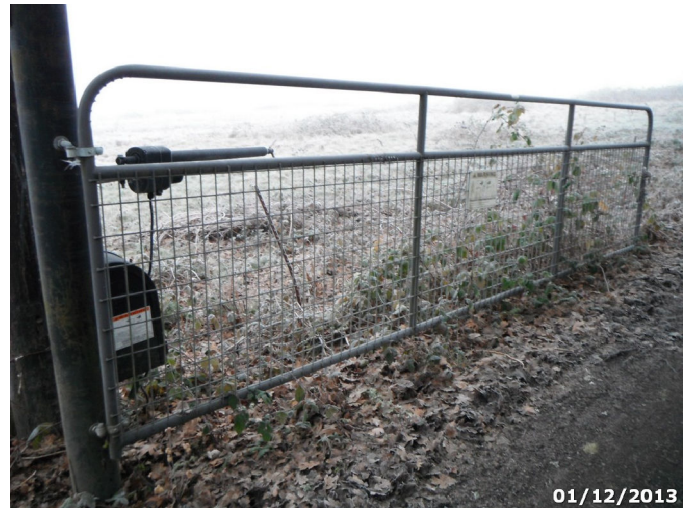
Photo: TUAL_C4_0531 Route: 406-001-0.07
Metal Open Rail Gate Electric
